FLORENCE COPPER INC.

Subject: 30-Day Report for AL Exceedance for Sulfate at Operational Monitor Well MW01-0

Underground Injection Control (UIC) Permit Number R9UIC-AZ3FY11-1

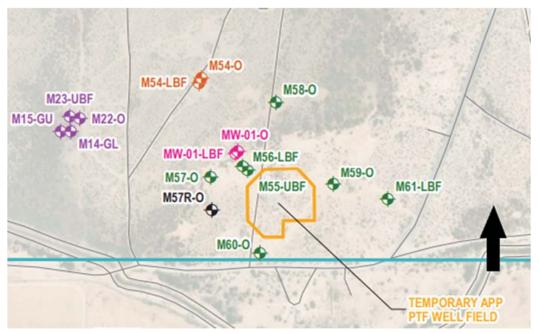
Figure 1. PTF monitor wells.

MW01-O is located northwest of Florence Copper's Production Test Facility (PTF) wellfield (Figure 1). The closest oxide observation wells are M57-O, to the southwest and M58-O to the northeast. The fourth quarter 2020 sample result for sulfate at M57-O was 69.5 mg/L and 25.4 mg/L at M58-O. These sulfate concentrations are well below the ALs. Downgradient from MW01-O, fourth quarter 2020 sulfate levels at point of compliance wells M54-O and M22-O were also well below the ALs at 51.8 mg/L and 51.7 mg/L, respectively.
